Thermo Electron Engineering Corporation, 85 First Avenue, Waltham, Massachusetts 02154

Report No. TE-4067-76-67

4E
SECOND QUARTERLY REPORT, 4
3 HEAT PIPE THERMIONIC
CONVERTER DEVELOPMENT 4

4. 1 October 1966 to 10 January 1967 9

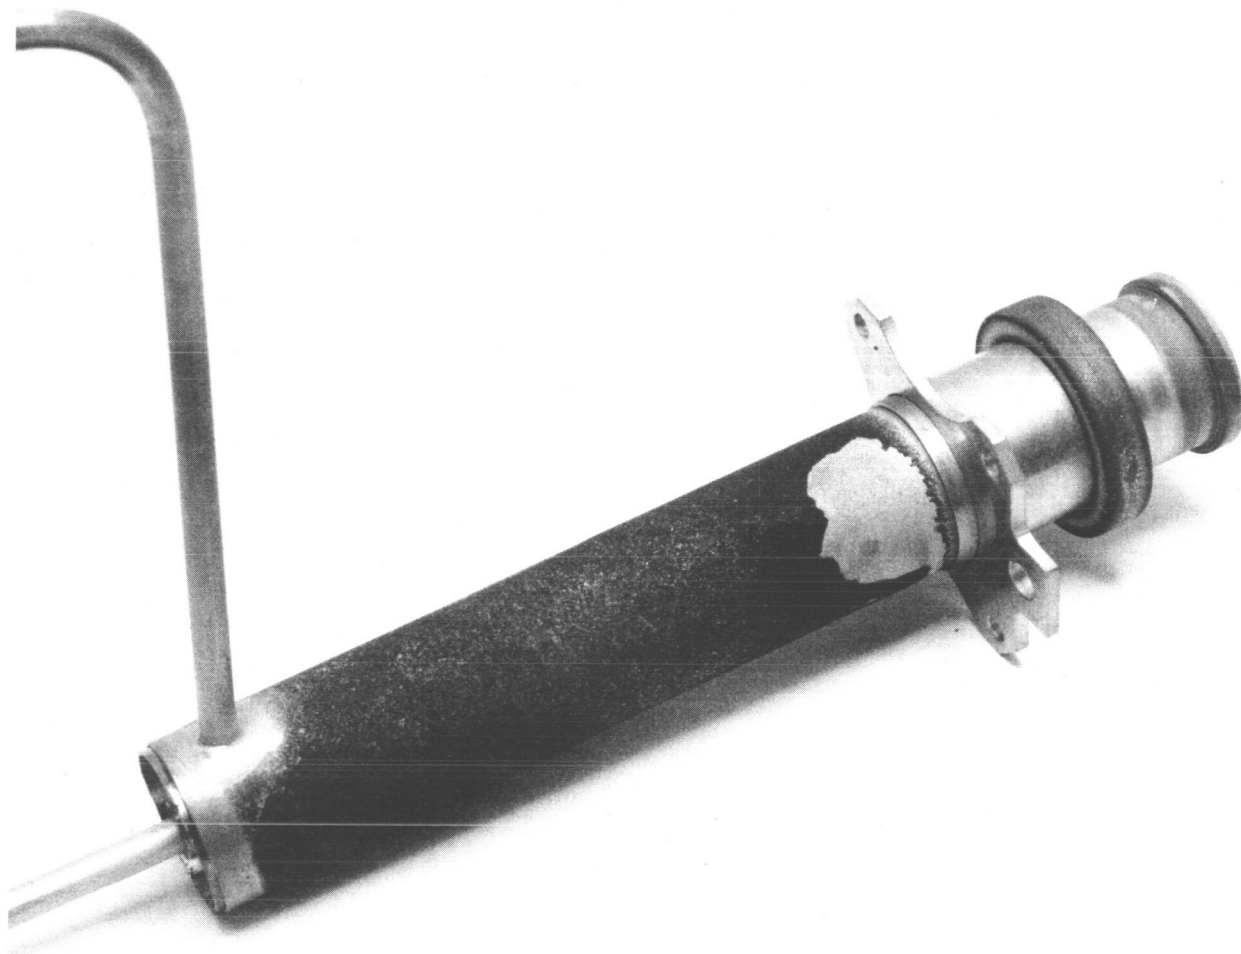
Next, the radiator tube subassembly, parts Nos. 9 and 12, as coated by New England Hard Facing with Norton's Rockide C coating, was welded to the edge of the collector. For this operation, the three parts of the seal assembly, Nos. 6, 10 and 11, were inserted around the radiator tube prior to fitting the tube to the collector. The weld required a very large amount of heat, which made the collector face concave by several thousandths of an inch. Further evidence of oxidation was noted. In spite of the close proximity of the seal ceramic, part No. 6, to the collector weld, it was found that the ceramic had withstood the exposure to the weld heat without cracking. After this step was completed the assembly was accidentally dropped, and the tube 13 broke at the collector end. The fracture was found to be completely brittle, which was a fact consistent with the evidence of oxidation near the welding areas. Since it was a simple matter to re-machine the collector to insert and weld a new cesium tube, and no other radiator tubes were immediately available to start a new assembly, a repair of the failed assembly was attempted. Before the new cesium reservoir tube was welded, however, the assembly was fired at 1400°C to clean the oxidized material. Figure 2 shows the assembly after welding the

new cesium reservoir tube. As can be seen, the 1400°C firing had caused some of the coating to disappear or flake off. Upon leak-checking this assembly, it was found that the collector weld to the radiator tube was cracked and leaked.

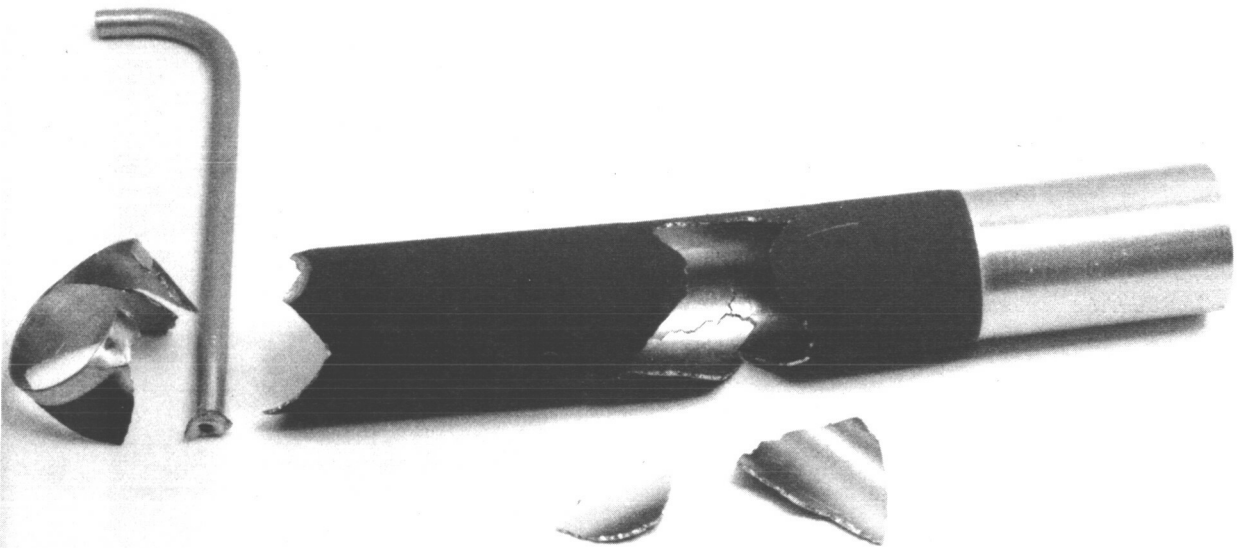
Figure 3

As the next attempt to fabricate the heat pipe model T/E-1 was about to start, a new batch of radiator tubes was received, coated with chromium oxide by the Linde Co. Because the surface of these tubes appeared contaminated, the tubes were cleaned with abrasive cloth and fired at 1400°C. When attempts were made to weld the sodium fill tube, part No. 12, the resulting point was found to be extremely brittle. Further examination, as shown in Figure 3, indicated that the entire

coated surface was brittle, but the uncoated portion of the tube was not. To check whether the embrittlement was common to the coatings of both Linde Co. and New England Hard Facing, the previously welded assembly of T/E-1-A was tested too. As Figure 4 shows, it also was brittle in the area of the coating.

Consequently, a meeting with a representative of the Linde Co. was held to discuss the details of the coating procedure and determine the cause of embrittlement. The representative took note of the facts, and two days later he submitted a tube of the original batch which had been returned to him in order to point out the problem of contamination during coating. This tube was not embrittled. It then became immediately obvious that the embrittlement must have resulted from the vacuum firing at 1400°C that had been used to clean the impurities noticed after coating. This tube sample was then heated for 15-minute intervals to 925°C , 1010°C , 1200°C and 1425°C , and it was found that after the first three firings it was ductile, but after the fourth it was totally embrittled over the coating area. Therefore, the chromium oxide coating material reacts with niobium at some temperature in the range from 1200°C to 1425°C to form a brittle compound.

In order to avoid a need to fire the heat pipe radiator tubes at high temperature to remove residual impurities, an improved fixture was designed and fabricated to carefully shield the portions of the heat pipe that should not be coated during the coating process. This fixture is shown in Figure 5 with a heat pipe radiator tube in position after coating. Figure 6 shows the coated tube as it appears after removal. With the use of such fixtures it is possible to avoid the need for firing the tubes after coating, and the embrittlement problem is thus avoided too.

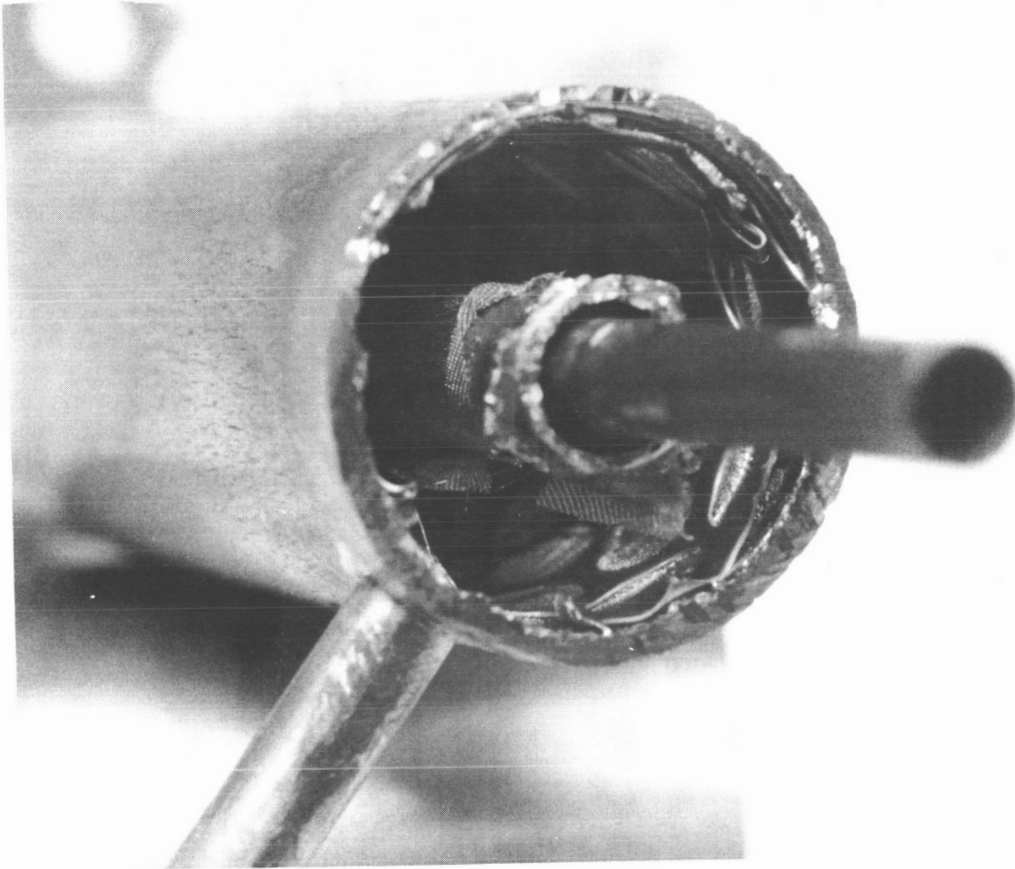
Figure 7

The assembly of this third heat pipe model was carried out in exactly the same manner as that of the second model. The radiator coating step was omitted, and the same welding difficulties were encountered when an attempt was made to weld the outer heat pipe tube, part No. 9, to the collector face. The welding arc jumped twice on the heat pipe tube, causing blow holes which had to be filled with fragments of niobium locally. In view of this experience, it was decided that in future heat pipe prototypes this weld would be performed by electron-beam welding, where it is possible to control the position of the welding bead with much greater accuracy. In order to avoid the same type of

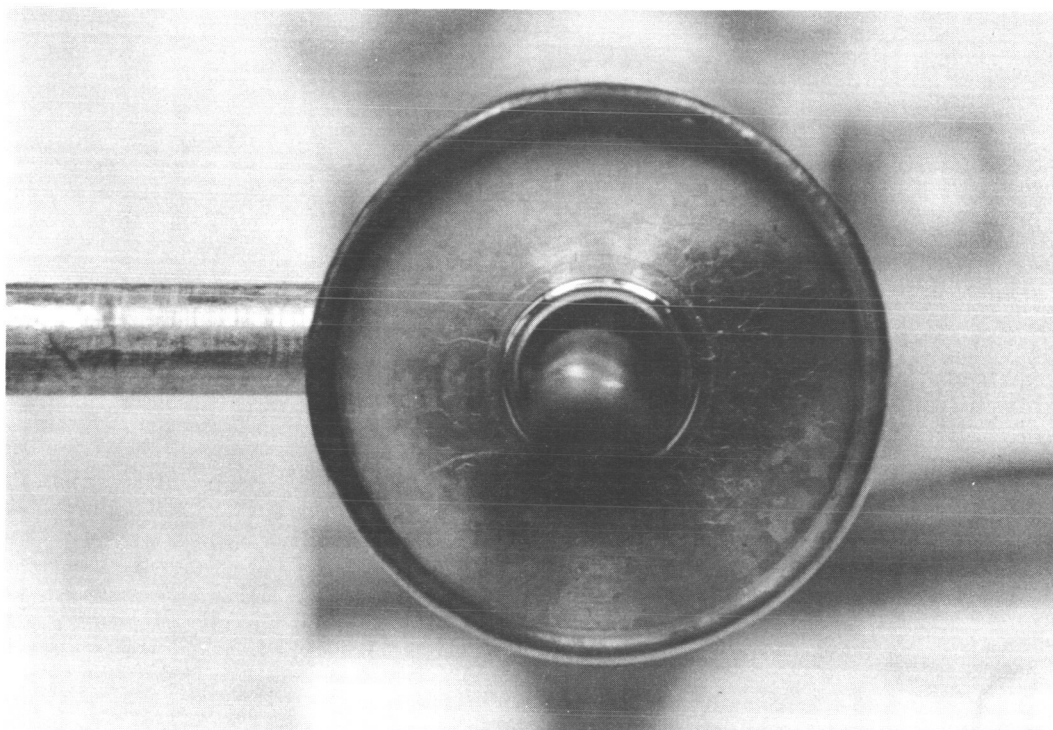
capillary mesh melting which had occurred with T/E-1-B, the capillary mesh was cut short from the end of the tube so that the point of closest proximity would be half an inch away from the welding bead locations. It was then possible to weld the end cap, part No. 21, in place without any difficulty. Figure 8 shows the appearance of the welds of the end cap, and Figure 9 shows the completed heat pipe model, where the repair to the joint at the collector face is apparent.

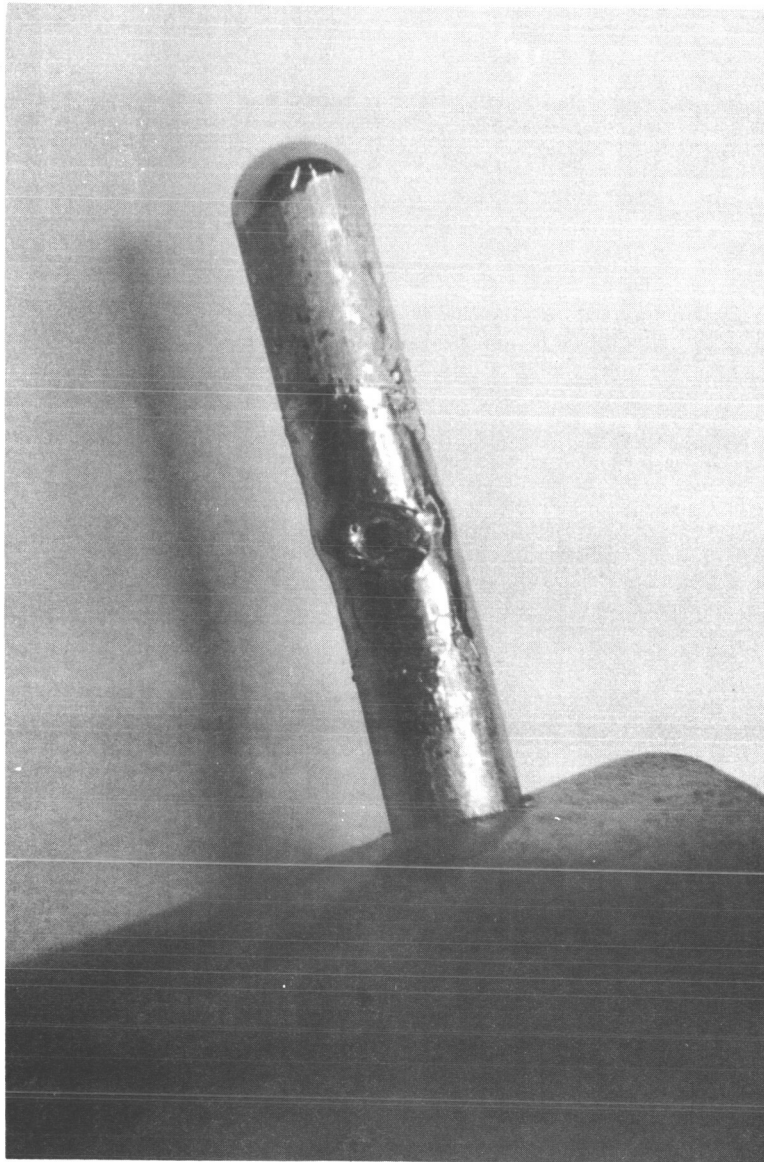
Figure 10

The electron-bombardment pinch-off operation was carried out by placing a one-turn 0.030-in.-dia. tantalum filament around the fill tube. This filament turn was 0.35 in. in diameter, and included a turn overlap of 0.20 in. so as to avoid the effect of local bombardment current, which is caused by lower filament temperature at the connection legs. When the fill tube was bombarded, the bombardment opposite the filament overlap area was found to be excessive; the fill tube melted locally at that point and developed a hole. Since a substantial amount of sodium vapor evaporated through this hole, the bombardment filament would no longer be maintained at a high potential difference with respect to the fill tube without violent arcing.

The vacuum system was opened to air in order to determine that this was what had happened. Since air leaked into the heat pipe in large amounts then, it was determined best to use the heat pipe structure to repeat the electron-bombardment pinch-off operation with a filament that did not have a turn overlap. This second pinch-off was successful, and is shown in Figure 10. The failed attempt is also evident in this figure. The complete structure of T/E-1-C is shown in Figure 11.
